3D Laser Scanning Results

ACME Wind Power

Albuquerque, NM

T-20

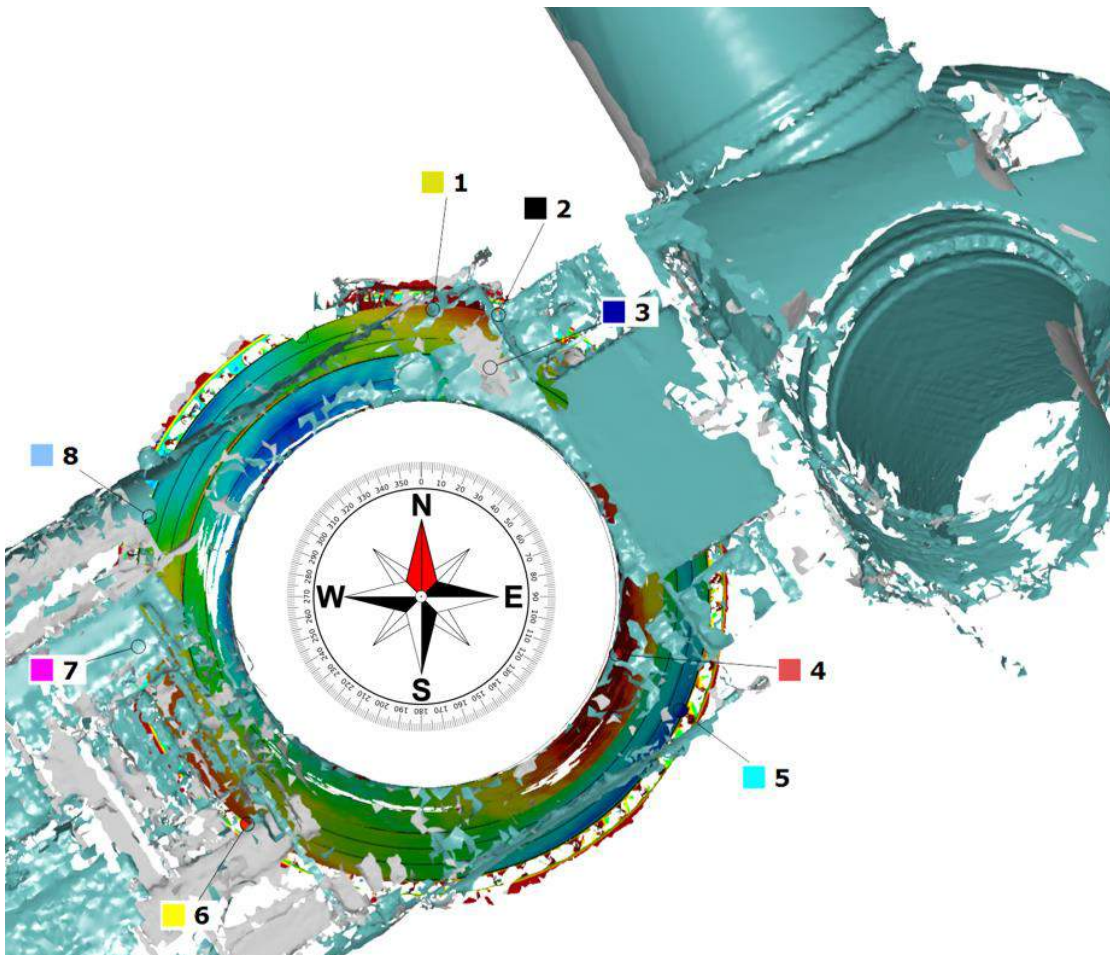
TOWER DEFORMATION MAP OVERVIEW

Deformation #	W (mm)	H (mm)	Angle (deg)	Height (m)	Max Deformation (mm)
1	1900	13570	2	10.97	-21.36
2	2375	17250	15	28.06	+18.68
3	2150	22430	15	50.26	-25.01
4	2585	10650	105	62.30	+29.36
5	2360	19540	115	27.00	-24.57
6	2250	20650	220	26.52	+20.57
7	1430	7925	260	10.62	+21.15
8	20550	1890	285	27.05	-23.57
